Intel® Celeron™ Processor Specification Update

Release Date: July 1999

Order Number: 243748-016

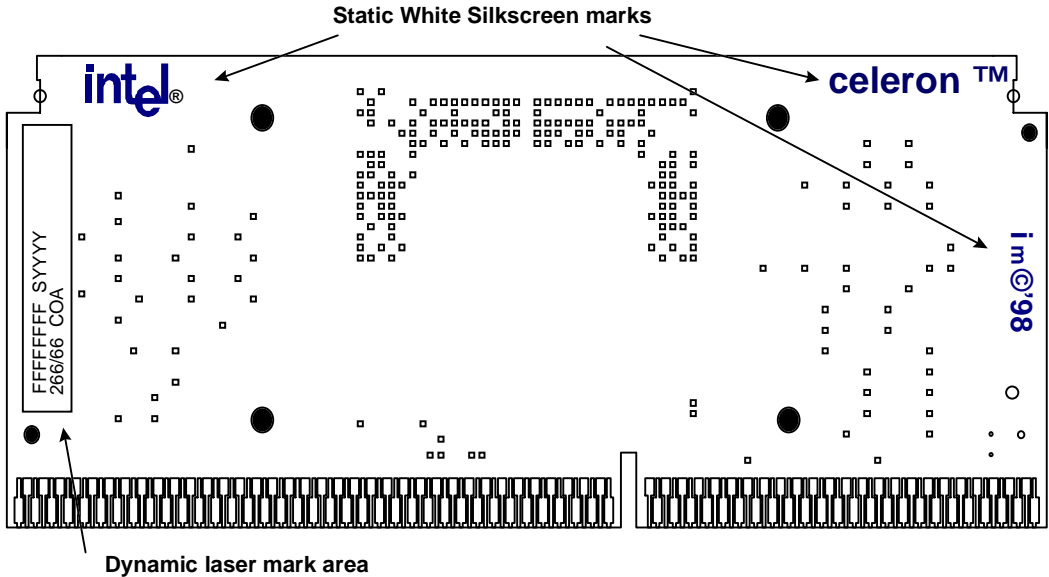
Intel® Celeron™ Processor and Boxed Intel® Celeron™ Processor Markings (S.E.P. Package)

- SYYY = S-spec Number.
- FFFFFFFF = FPO # (Test Lot Traceability #).
- COA = Country of Assembly.

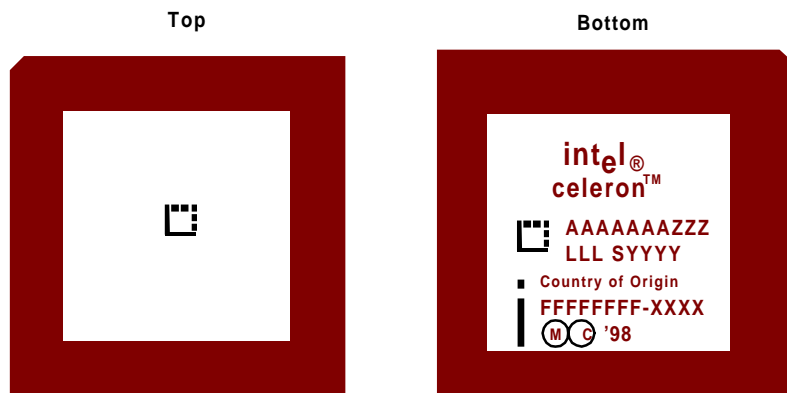
Intel® Celeron™ Processor and Boxed Intel® Celeron™ Processor Markings (PPGA Package)

- AAAAAAA = Product Code
- ZZZ = Processor Speed (MHz)
- LLL = Integrated Level-Two Cache Size (in Kilobytes)
- SYYYY = S-Spec Number
- FFFFFFFF-XXXX = Assembly Lot Tracking Number
